HPP Mestiachala Priority Projects

Attachment 2 Detachment zone base map, Scale
1 : 25,000

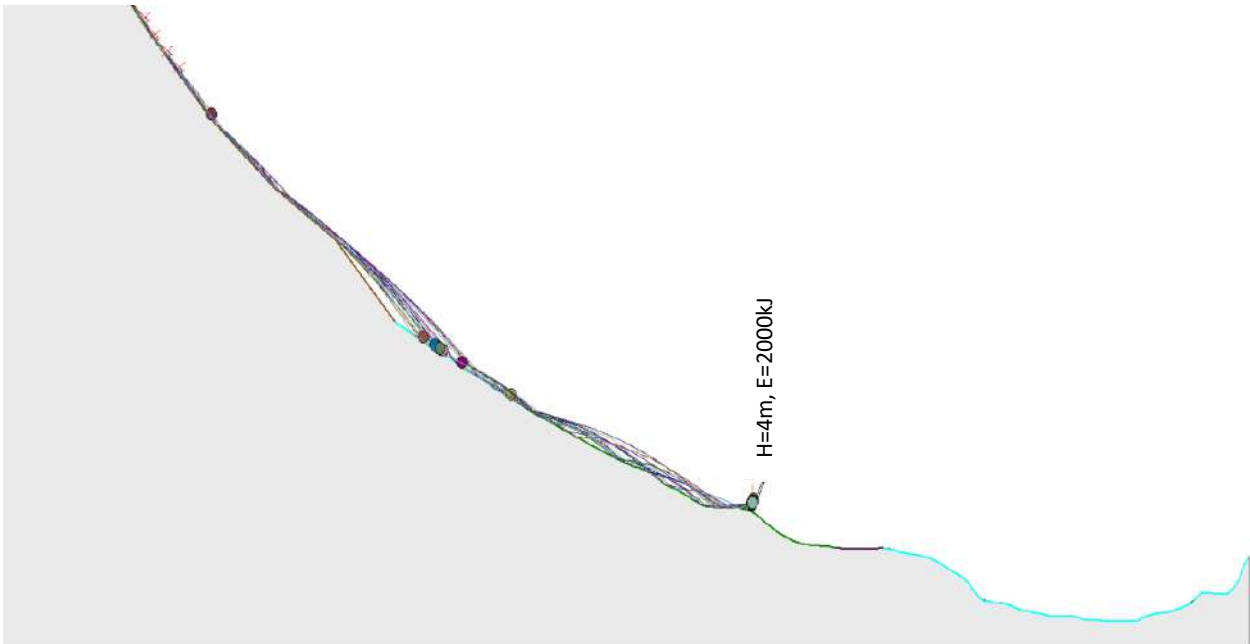
Tab. 8-3: Simulation result with a rockfall barrier at the position of the road (x = 194 m).

X_b [m]	Y_b [m]	HpMax [m]	V_{max} [m/s]	E_{max} [KJ]
194,318	28.988	1.404	12.153	1,629.819

Fig. 8-5: Visualisation of the simulation result of M-D4 t_1 with placing a rockfall barrier in front of the road.

The determination of the ideal location of a protection structure is crucial and depends on multiple factors such as the jump height of the (design) boulder and its remaining energy at the envisaged position. As such, we strongly recommend placing a protection measure on the closest edge of the upper road section (x = 194 m). The simulation has shown that all design boulders can be stopped by a rockfall barrier of at least 2,000 kJ at x = 194 m (see Fig. 8-5). In Tab. 8-3 the characteristic values of the design boulder ((HpMax) Maximum height, (V_{max}) Maximum velocity, (E_{max}) Maximum energy) at the time of impact at the barrier are shown.

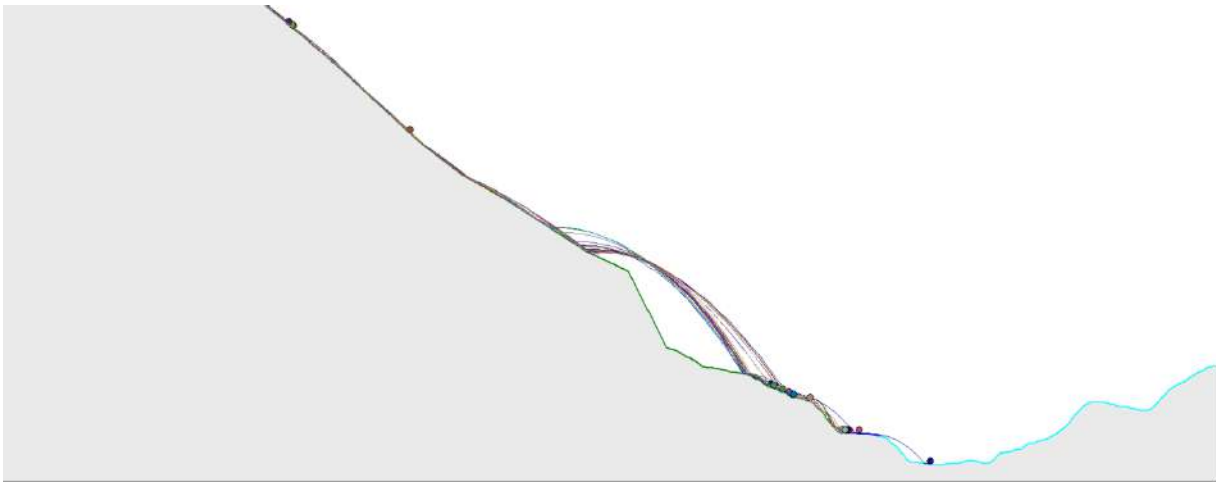
The second rockfall event at M-D4 (M-D4 t_2) was calculated with the boulder characteristics summarized in Tab. 8-4, and the results are visualised in Fig. 8-6. While some design boulders did not reach the investigated road section, others did reach the road and pose therefore a hazard to infrastructure, penstock and the operating staff. In Tab. 8-4 the characteristic values ((HpMax) Maximum height, (V_{max}) Maximum velocity, (E_{max}) Maximum energy) of the design boulder impacting the road at position $x = 287$ m are presented.

Tab. 8-4: Simulation result without placing a rockfall barrier at the position of the road ($x = 287$ m).

X_b [m]	Y_b [m]	HpMax [m]	V_{max} [m/s]	E_{max} [KJ]
287	20	3.8	17	2,664

Fig. 8-6: Visualisation of the simulation result of M-D4 t_2 without placing a rockfall barrier.

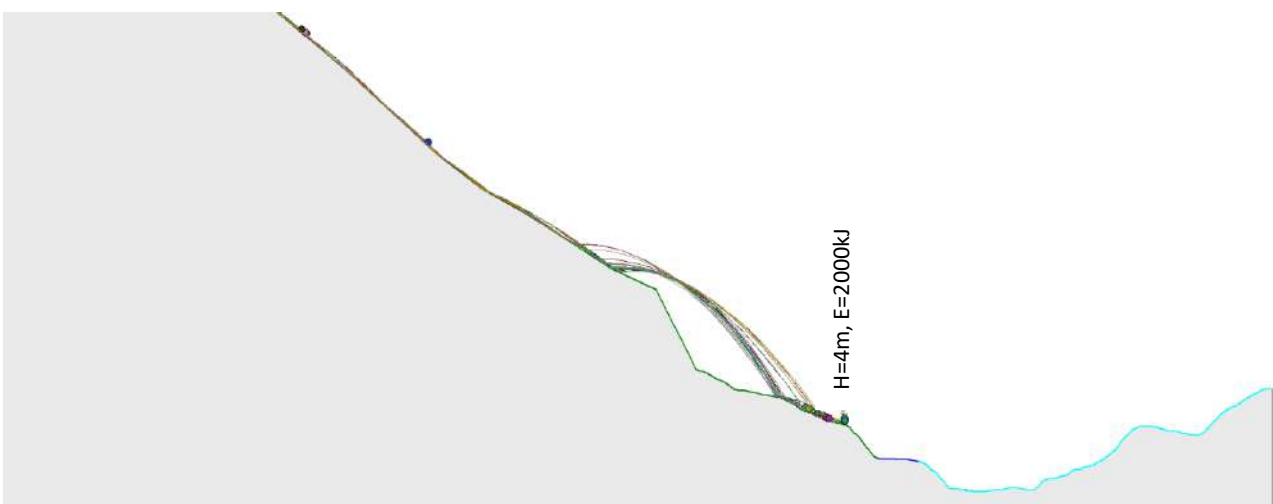
Tab. 8-5: Simulation result with a rockfall barrier at the position of the road (x = 278 m).

X _b [m]	Y _b [m]	HpMax [m]	V _{max} [m/s]	E _{max} [KJ]
277.688	29.462	0.958	12.777	1,724.671

Fig. 8-7: Visualisation of the simulation result of M-D4 t_2 with placing a rockfall barrier in front of the road.

The simulation has shown that all design boulders can be stopped by a rockfall barrier of at least 2,000 kJ at x = 278 m. The results are visualised in Fig. 8-7, and in Tab. 8-5, the characteristic values of the design boulder ((HpMax) Maximum height, (V_{max}) Maximum velocity, (E_{max}) Maximum energy) at the time of impact at the barrier are shown.

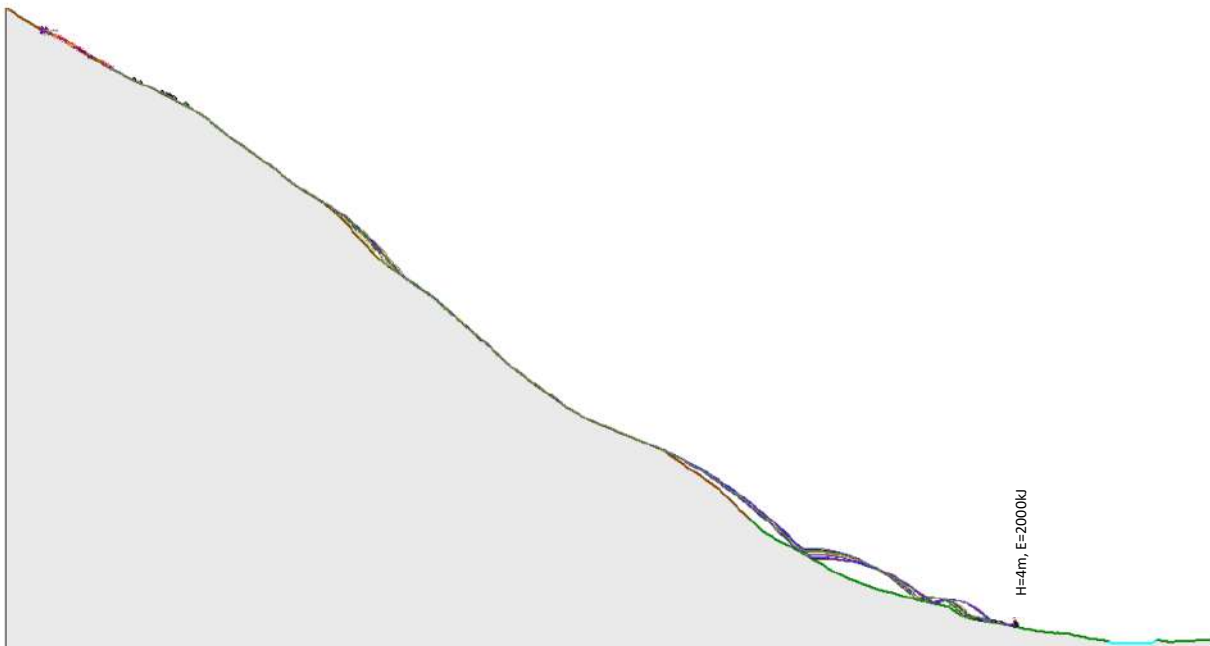
X_b [m]	Y_b [m]	HpMax [m]	V_{max} [m/s]	E_{max} [KJ]
881.509	23.298	2.844	8.406	1,047.536

Fig. 8-12: Visualisation of the simulation result of M-D6 t_2 with placing a rockfall barrier.

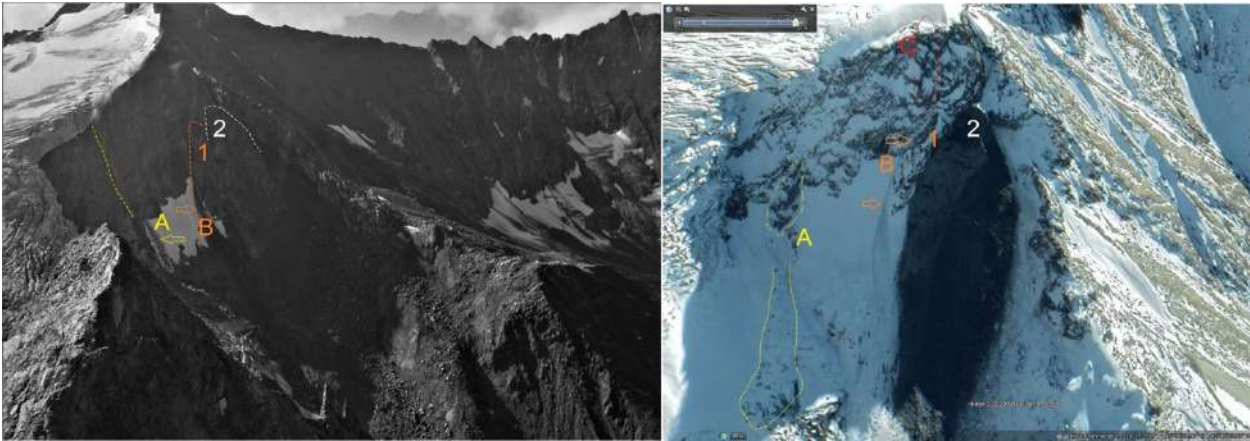
The entire release area shows high activity (minor to large rockfalls and active joints; see debris plumes on snow fields in Fig. 8-14) as can be inferred from our previous investigations (see report_02). This means that the detachment zone has obviously not come to a semi-stable condition after July 2019, but future events must be expected. Monitoring is strongly recommended (see Chapter 11).

Fig. 8-14: Activity indicators. Left: Overview of the detachment area from helicopter in August 2019. Right: Google earth image of October 2019. **2**: Rock tower collapse in 10/2019; **1**: near-future event; **A** and **B**: joints with active debris release, **C**: new joint developing (for further explanation see also our Report 02).

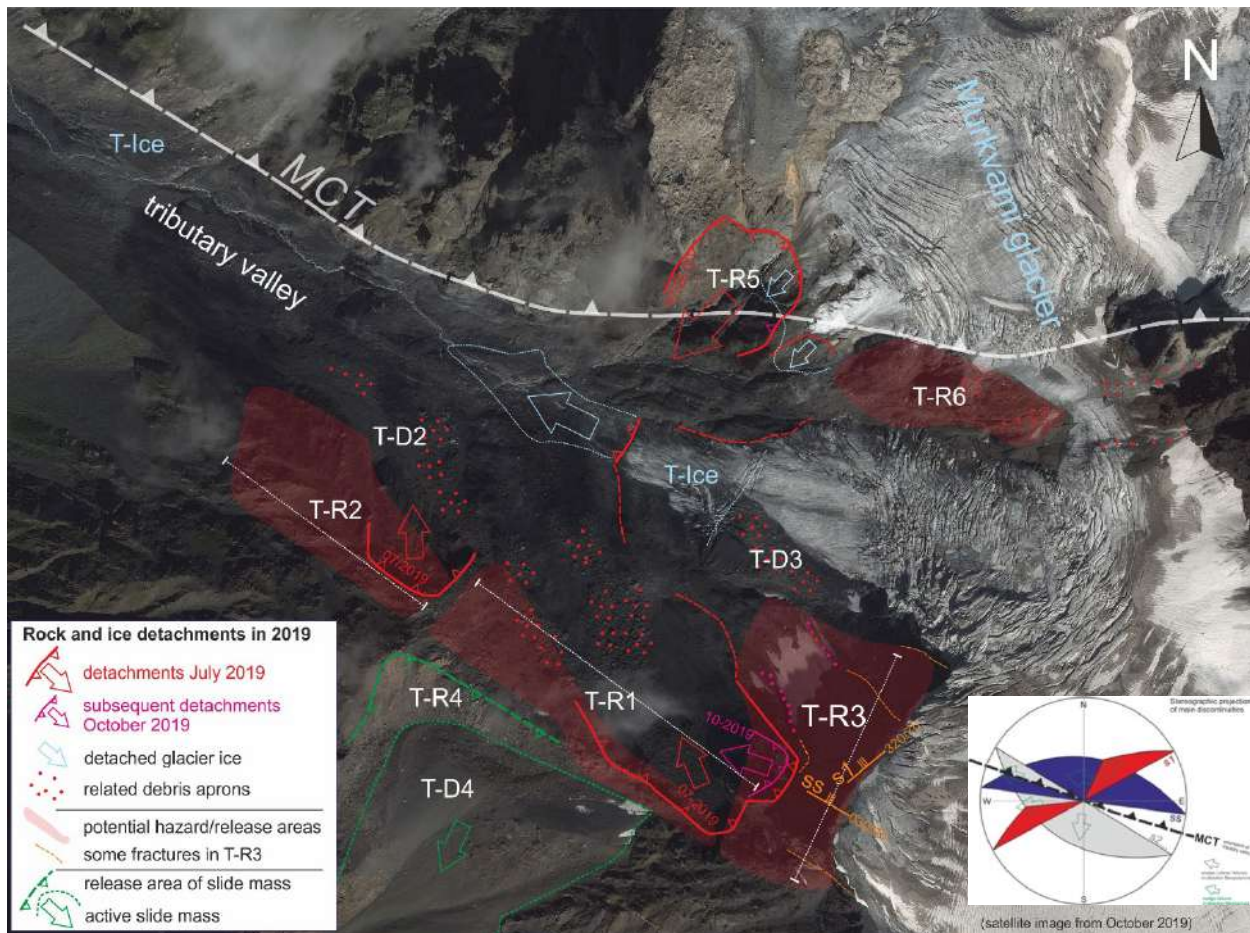
Fig. 8-15: Overview of the entire detachment area of the 2019 event (based on Report_02).

The probability of re-occurring rock slides in T-R1 to T-R6 is thus comparably high. Regarding the following factors, we have to assume **future rock slope failures within the next 30 years (EF 2: 1-30 years)**:

The maximum volumes (magnitude) can be estimated as roughly up to 500,000 m³ from the area of T-R3 / T-R1 and 300,000 m³ from T-R6. This is a rough number since detail data (e.g. DTM) is missing. Minor rock slides in the scale of several 100s to 10,000s m³ might occur anytime, as could be seen in October 2019. A near-future event expected in the next years is indicated in Fig. 8-16 with an approximate volume of around 50,000 m³ (very large rockfall).

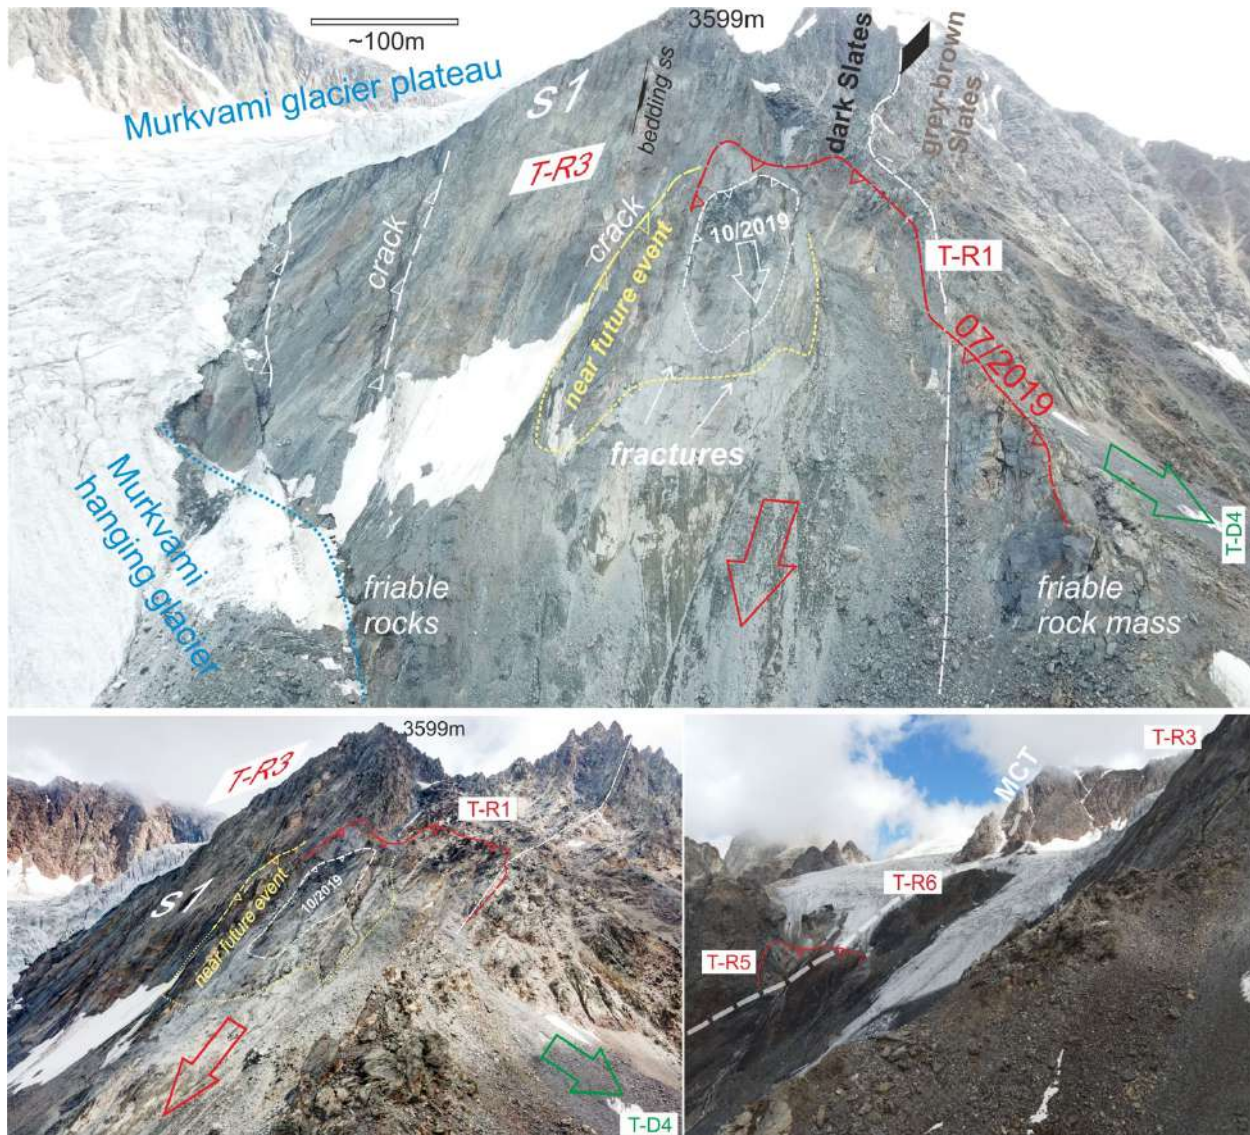
Fig. 8-16: Top and bottom left: Overview of release areas T-R3 and T-R1 with geomechanical condition and geometry of recent detachments. Bottom right: View to the North on MCT shear zone with T-R5 and T-R6. Note the steepness of T-R3.

the impact of Murkvami glacier, its load and its subsurface rock conditions on the overall stability of the steep rock face T-R3, which could be investigated by georadar.

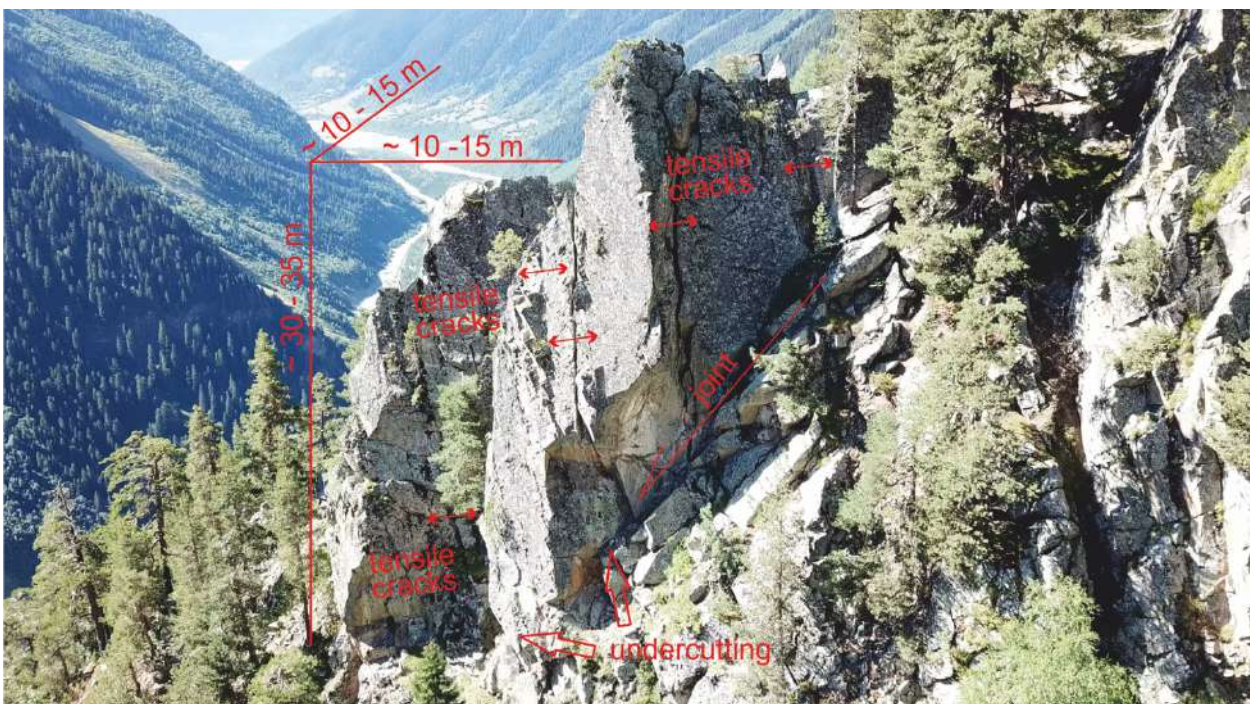
Fig. 8-17: Instable rock towers in the west slope above gallery (M-R3b). Measured rock volumes range between $2,500\text{m}^3$ and $10,500\text{m}^3$ (mainly class: large rockfall).

The **rock towers at M-R3b** are located above the gallery and show clear indications of mountain splitting. Drone imaging resulted in detailed insight into the structural situation (Fig. 8-17). More or less vertical or steeply inclined cleavages (most likely s1 and s2) serve as detachments along which the ridge is splitting apart. The fracturing appears rather fresh in parts and hints at active deformation. Also undercutting can be observed in the images.

It has to be assumed that wedge-shaped parts of these towers or the entire towers can detach and fail, leading to rockfalls of large volumes up to some 1,000s of m^3 . We roughly assume a frequency class of 1-30 years (EF 2). More precise assumptions are only possible incorporating monitoring data and detailed DTM.

Rockfall from M-R3b will most likely impact on top of the gallery. The rock mass of Jurassic slates will disintegrate into a blocky mass, which will override the gallery. A volume of up to 10,000 m³ at maximum has to be assumed. Supporting measures are recommended for the gallery (see Chapter 11).

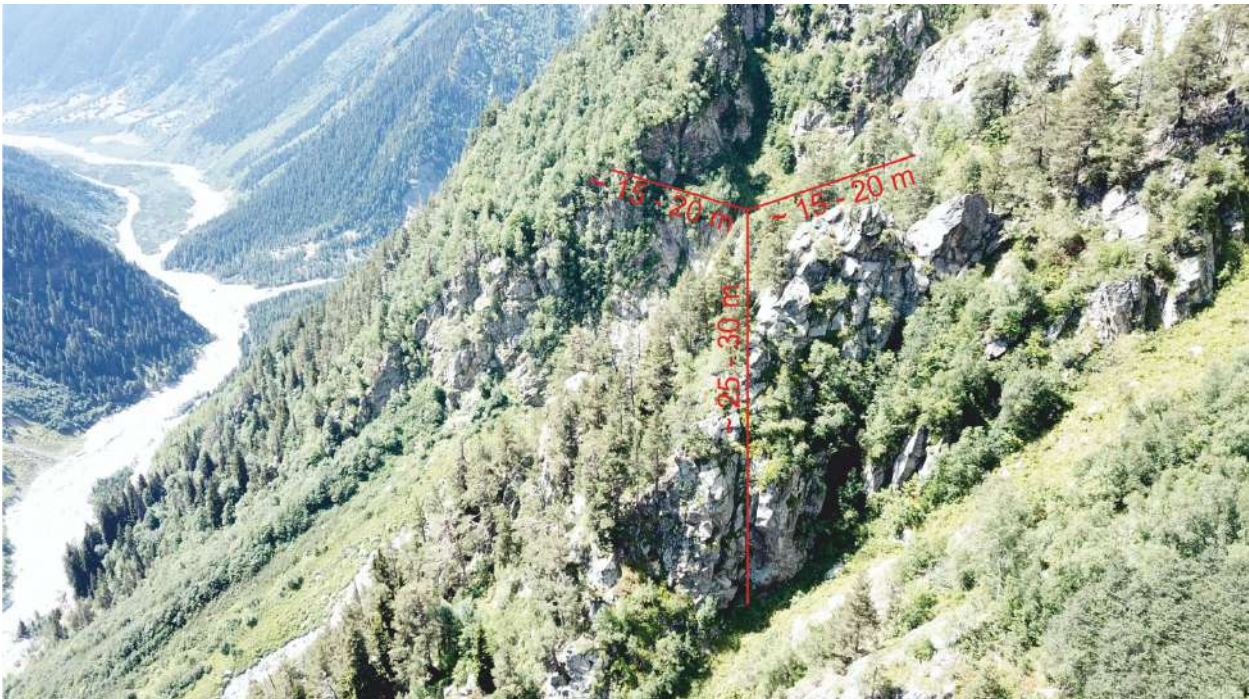
A **friable rock slope is located in M-R5b** as shown in the following image (Fig. 8-18). Further details can be seen in Fig. 4-8 and Fig. 4-9. The geomechanical situation is characterized by strongly fractured rocks with an apparent cleavage/joint set dipping eastward, parallel to the Mestiachala valley flank. This is a typical fault orientation in this region.

It has to be assumed that this area is an active release area with annual minor events, but also a probable large or even very large rockfall event in a range of 1-30 years (EF 2). More precise assumptions are only possible incorporating monitoring data and detailed DTM.

Fig. 8-18: Instable rock towers in the west slope (M-R5b). Measured rock volumes range between 5,000m³ and 12,000 m³ (mainly class: large rockfall). Note the steep joint parallel to the slope.

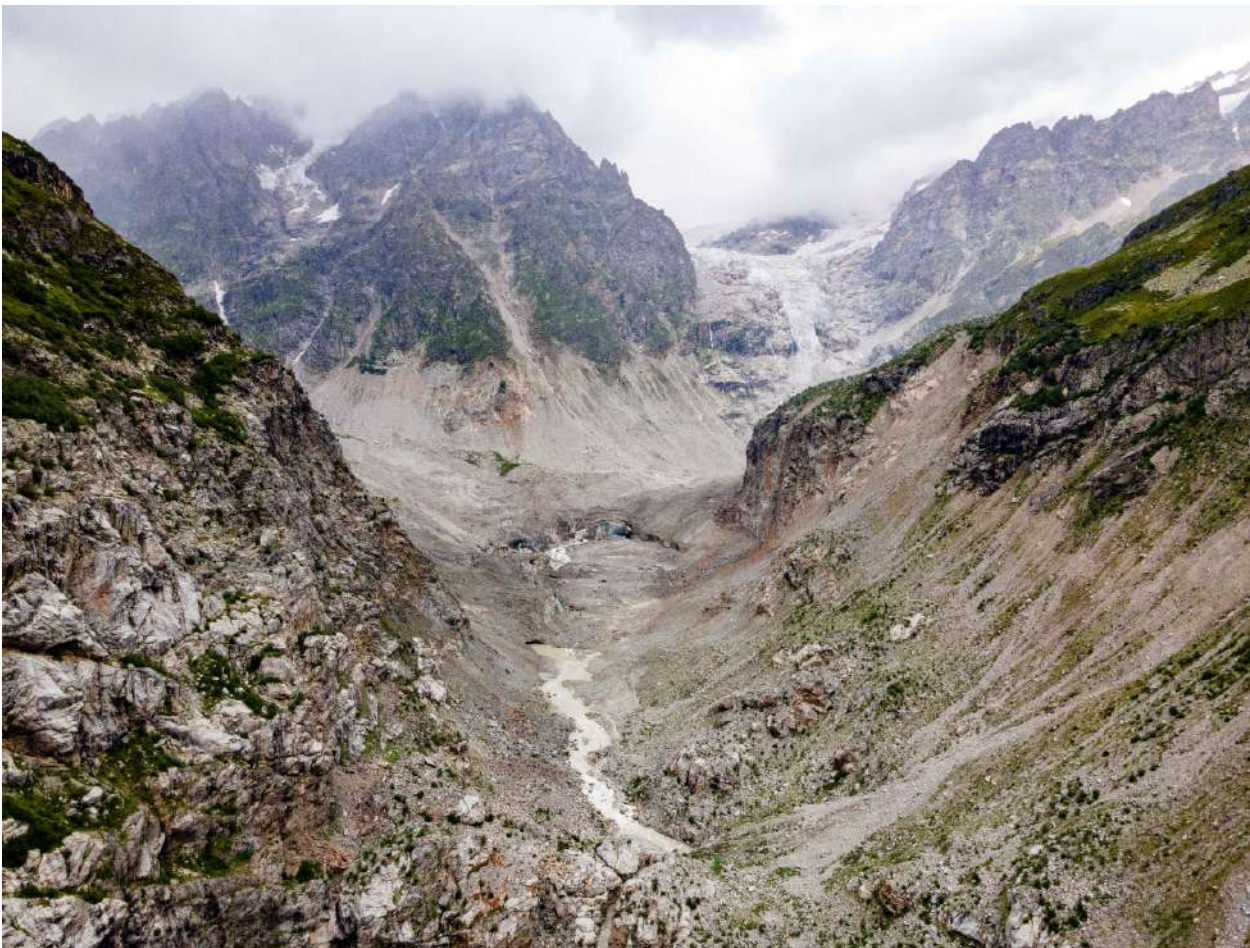
Fig. 9-4: Lekhziri glacier, with the glacier mouth from the compound valley-type glacier originating from the two main eastern and western flows. Northern Lekhziri glacier can be seen in the background, and in the foreground the bedrock constriction is located (© Sebastian Resinger)

At E318,248, N4,779,038, right below the glacier mouth, a narrow passage composed from bedrock is located in the course of the channel. This constriction acts as a bottleneck by retaining bedload during average discharge conditions, however, it is not sufficiently large in case of high-discharge event. This was confirmed during the field visit as well as by means of analyzing high-resolution satellite imagery (see also Fig. 9-4, foreground).

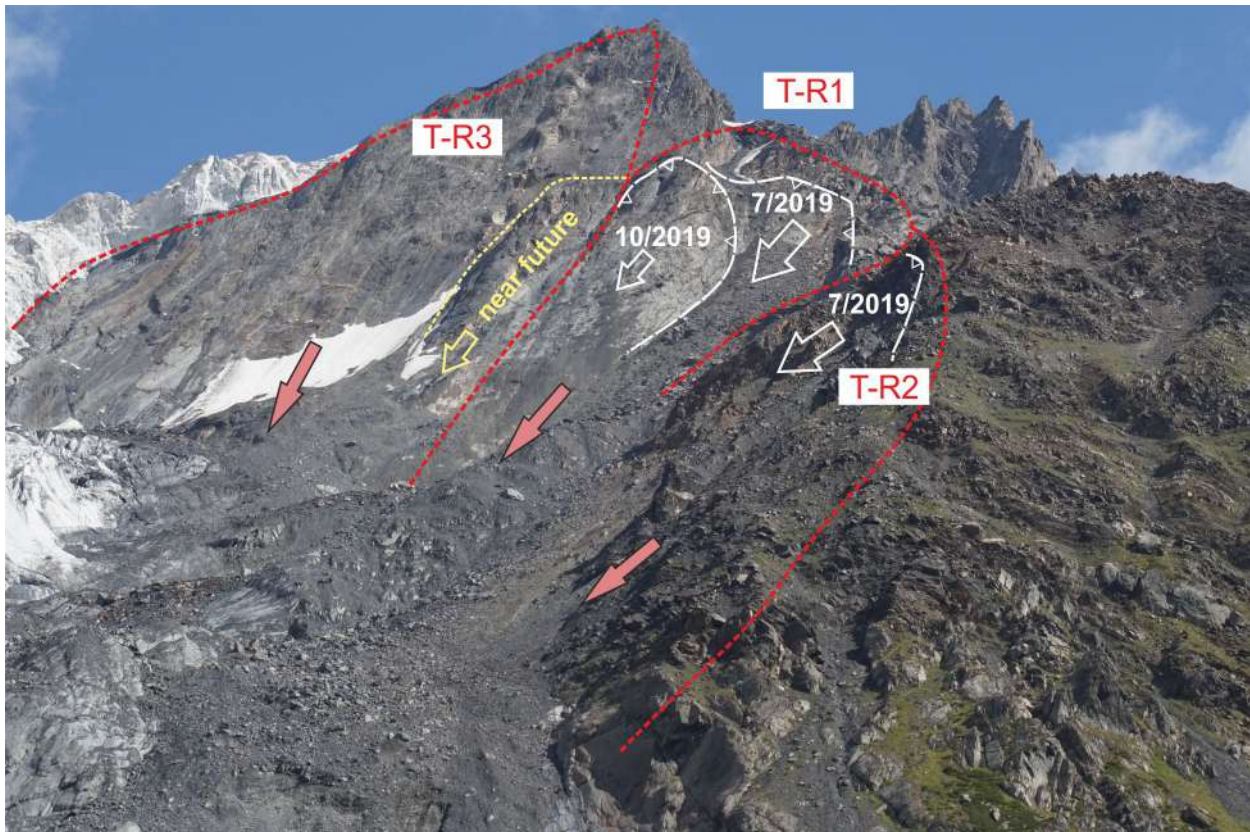
Fig. 11-2: Image showing three main release (detachment) areas (T-R1, T-R2, T-R3) where future events are to be expected. The photo was taken in August 2019. We have indicated the releases of July 2019. The younger detachment of October 2019 is also shown as well as the potential next medium-large event (up to 10.000s m³).

The hazardous areas which need to be monitored are shown in Fig. 11-2. The three main release areas (T-R1-3) include those detachment areas, where future events have to be expected to be released from the rock cliff. The red arrows are marking the transit zone where most likely individual rockfall events will be visible and can be noticed before an event of larger magnitude will occur. Therefore, the hazard areas 1-3 have to be observed with a telescope or binoculars from the sentry point during the course of the day. In addition, smaller events such as individual rocks being released or dust clouds, which appear in the hazard zone or in other sections of the tributary valley, need to be documented in the event documentation sheet proposed in the Attachment 10.
