HPP Mestiachala Priority Projects

Attachment 2 Detachment zone base map, Scale
1 : 25,000

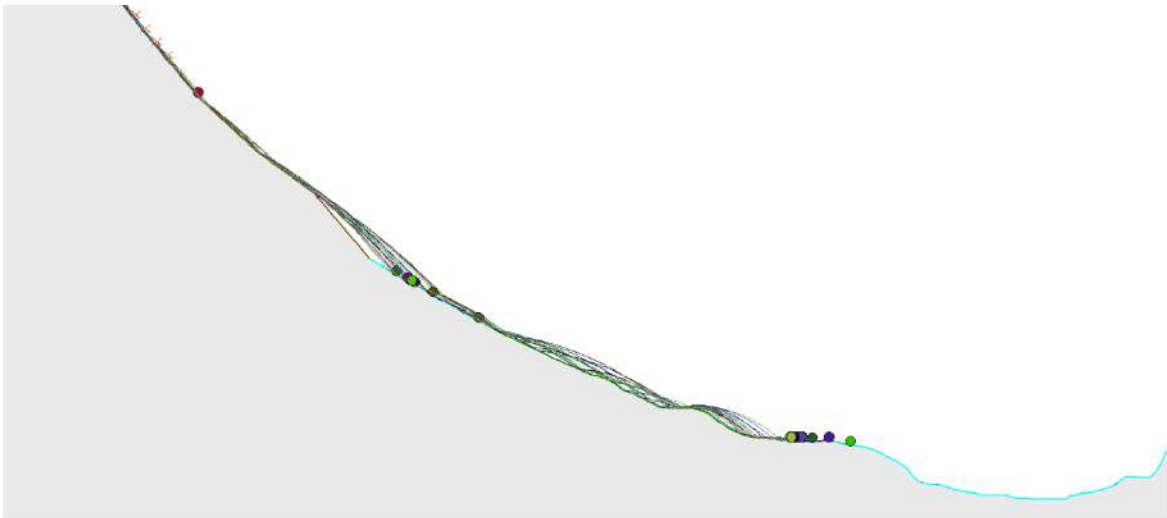
Fig. 8-4: Visualisation of the simulation result of M-D4 t_1 without placing a rockfall barrier.

The determination of the ideal location of a protection structure is crucial and depends on multiple factors such as the jump height of the (design) boulder and its remaining energy at the envisaged position. As such, we strongly recommend placing a protection measure on the closest edge of the upper road section (x = 194 m). The simulation has shown that all design boulders can be stopped by a rockfall barrier of at least 2,000 kJ at x = 194 m (see Fig. 8-5). In Tab. 8-3 the characteristic values of the design boulder ((HpMax) Maximum height, (V_{max}) Maximum velocity, (E_{max}) Maximum energy) at the time of impact at the barrier are shown.

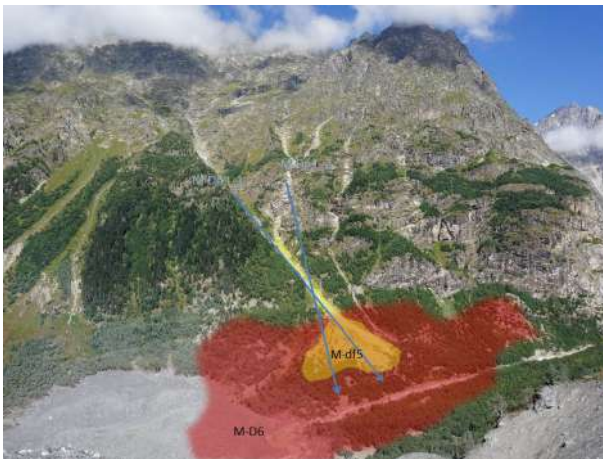
North of the deposition of the 2019 event considerable rockfall activity occurs, posing a hazard to the position of the planned new intake 1. According to our findings from field investigations, the following two cross sections (M-D6 t₁ and M-D6 t₂, see Fig. 8-8 and Fig. 8-9) were distinguished as potential rockfall trajectories and corresponding rockfall simulations were performed. Trajectory 1 follows the incision where the M-df5 flow is located. The second trajectory (M-D6 t₂) is assumed to detach from the steep rock face to the right of M-D6 t₁ crossing trajectory 1 with a run-out at the lower plateau close to the planned new intake 1. The computer simulation was performed only for M-D6 t₂ since this is closer by the planned new intake 1. The boulder characteristics for the simulation are summarized in Tab. 8-1.

Fig. 8-8: M-D6 trajectories 1 and 2; view to NW.

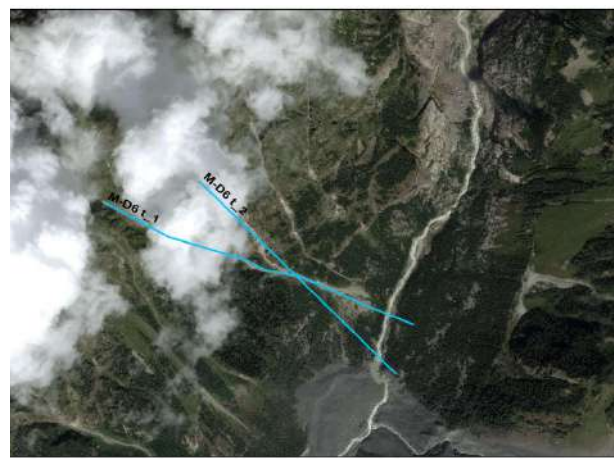
Fig. 8-9: Satellite image of M-D6 trajectories 1 and 2.

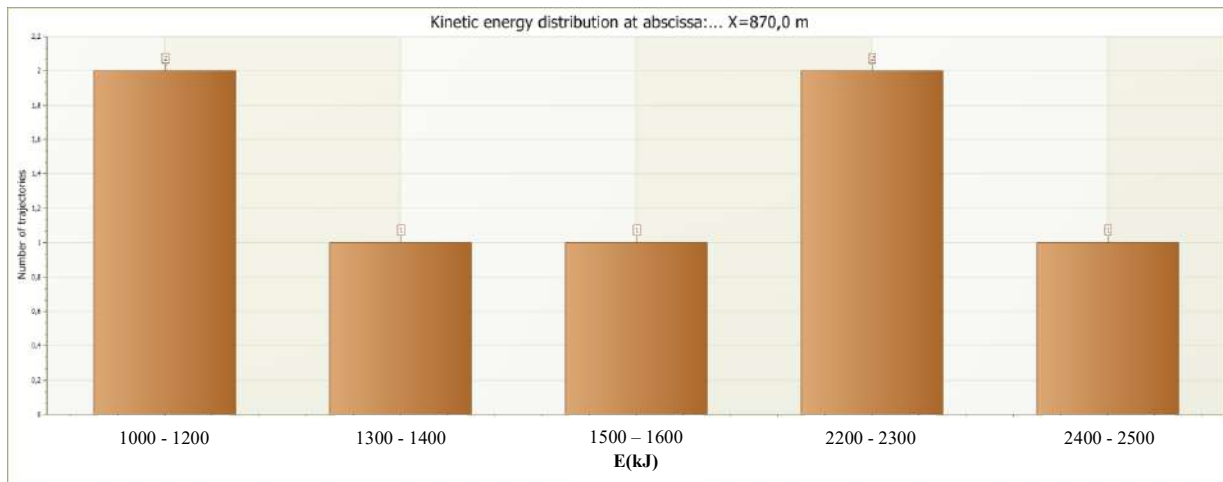
As so far the exact location of the new intake 1 structure was not defined, the position $x = 870$ m was chosen for demonstrative purpose. Close to this position the simulation results indicated that several boulders hit the ground and bounce back. Hence, the energy level in front of this point is very high with several 1,000 kJ. Afterwards a large portion of the energy is dissipated and the remaining energy histogram is visualised at $x = 870$ m in Fig. 8-10. The rockfall simulation for M-D6 t₂ (Fig. 8-11) provided evidence for rocks impacting at $x = 870$ m with energy levels up to 2,450 kJ. This hazard should be taken into account when choosing an appropriate position for the new intake 1 structure.

Fig. 8-10: Kinetic energy distribution at ($x = 870$ m)

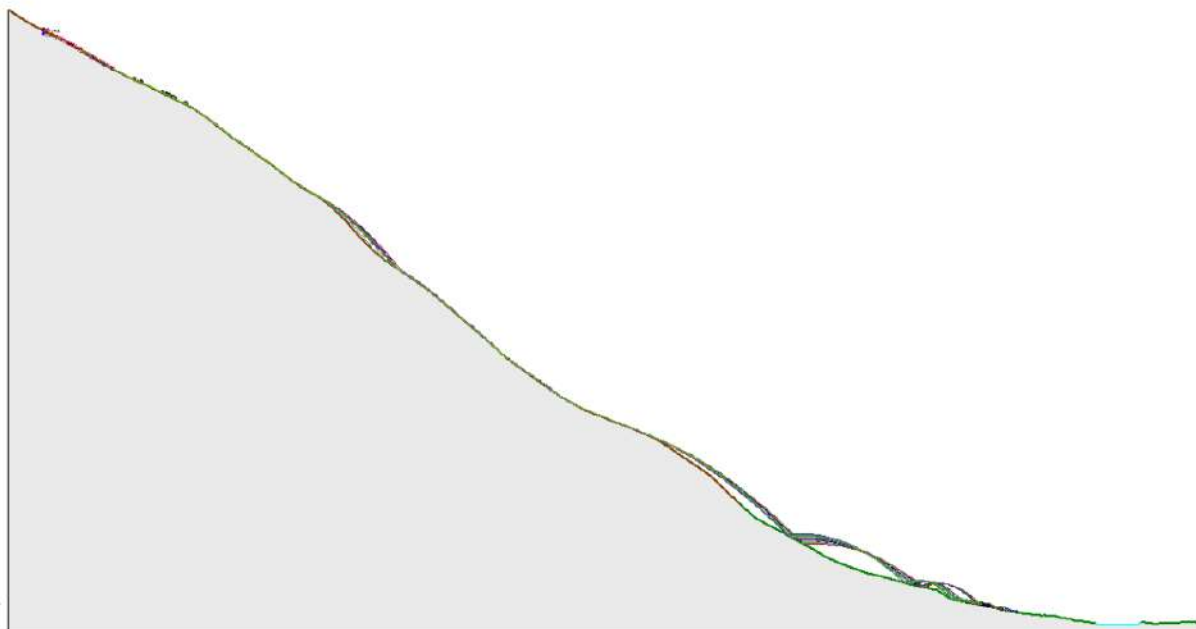
Fig. 8-11: Simulation result of M-D6 t_2 without placing a rockfall barrier.

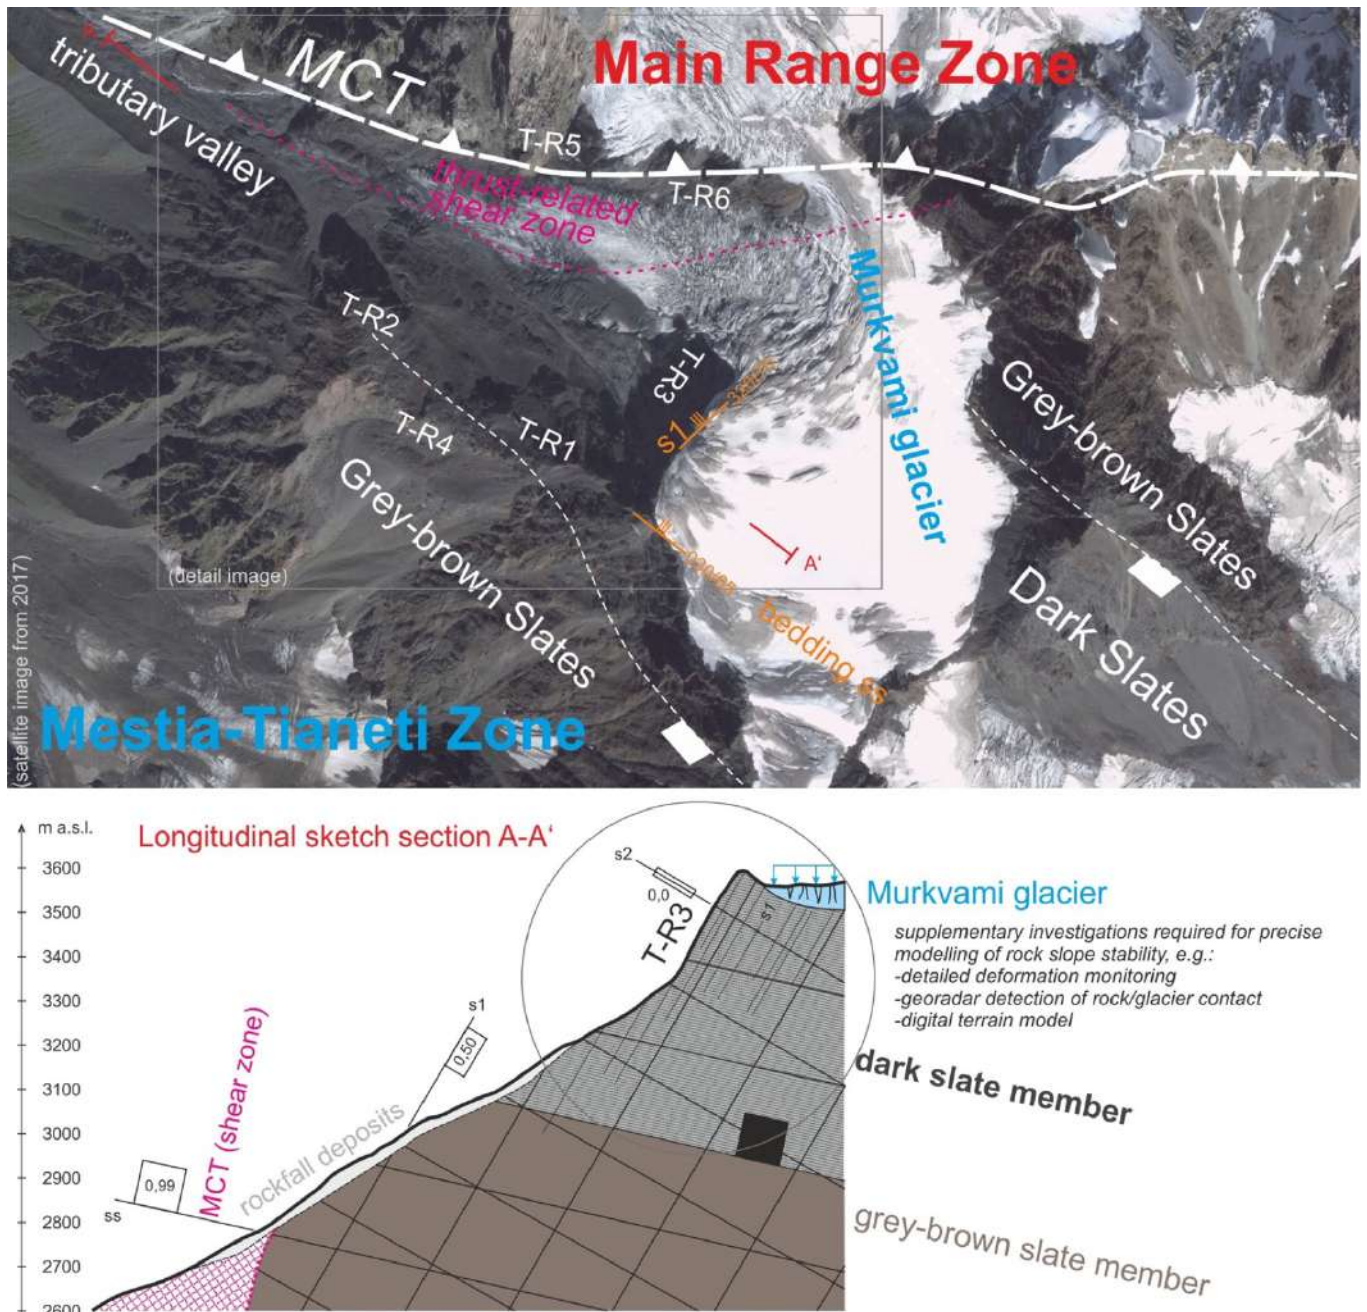
The detachment zone of the 2019 event s.l. is composed of several areas prone to release (T-R1 to T-R6), which can be seen in detail in the images below (e.g. Fig. 8-15, see also Chapter 3.2). The geology is highly unfavorable. The whole sequence of Lower Jurassic rocks of the Mestia-Tianeti Zone, which comprises different slate members, dips to the Northeast and is cutoff obliquely by the steep MCT thrust zone. The critical rock faces (esp. T-R3 and T-R1) are located in a few 100 m thick member of comparably weak dark slates, characterized by fine bedding and intense cleavage. The majority of material of the 2019 event is derived from this dark slate member. In addition, the cleavage is very pronounced and serves as main detachment (s1).

The hanging Murkvami glacier tongue covers the shear zone of the MCT. The Jurassic slates and sheared crystalline rocks (mainly gneisses) form a melange of friable rock masses with reduced strength. Here, detachments T-R5 and T-R6 are located.

Fig. 8-13: Overview of the geology in the Murkvami area (satellite image from 2017 obtained from <https://pereval.online/object/2812#image-12>). Longitudinal section along rockfall travel path.

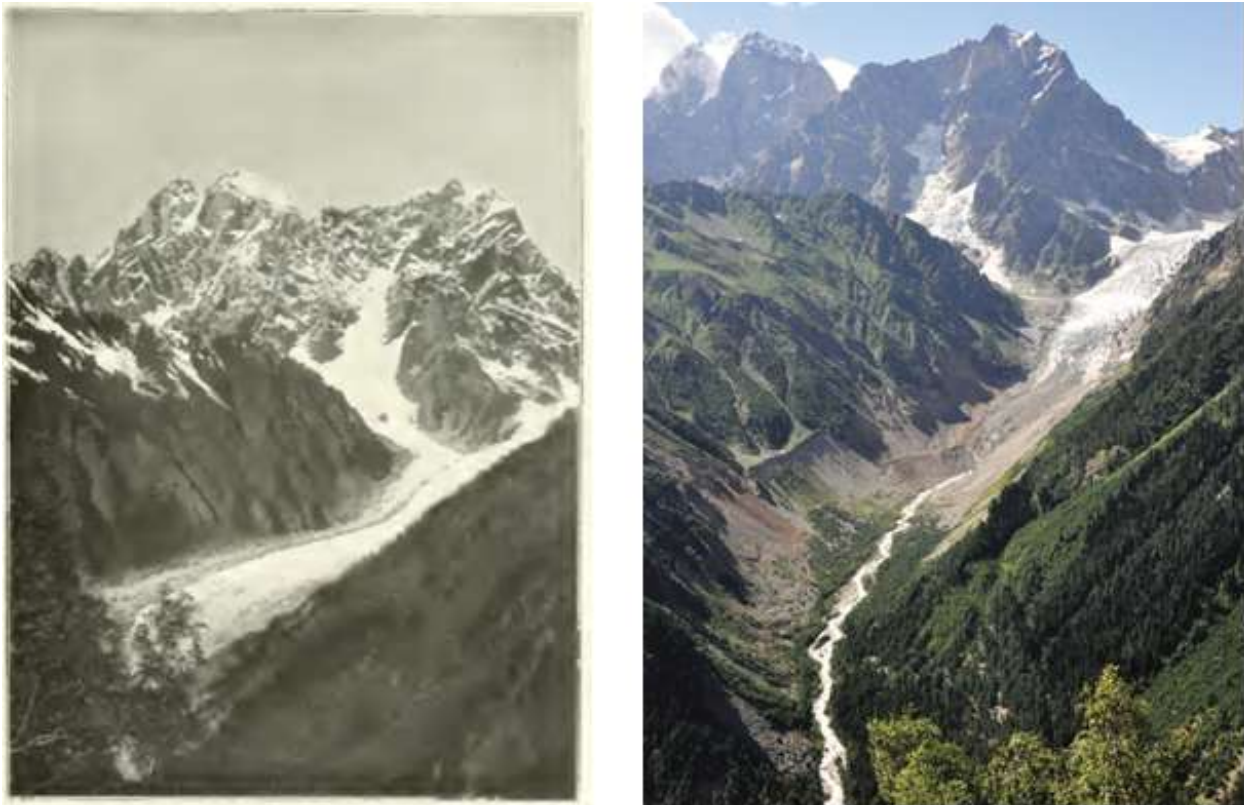
Fig. 9-1 illustrates the glacier retreat from 1887 to 2011. It is evident that the glacier filled the entire valley and reached up to the height of the lateral moraines (named “1850” moraines in the preliminary report, visible on the right image). The loose material uncovered by the retreat of the glacier is clearly visible in the right image. The ongoing glacier retreat gradually uncovers more loose material of different grain sizes, which can be mobilized by subsequent erosion and remobilization processes and might pose a threat to the structures of HPP1 (see Chapter 5 for more details).

Fig. 9-1: Left: Chalaati glacier 1887 (DECHY 1905: 313), Right: Chalaati glacier 2011 (TIELIDZE 2019: 73)

The maximum extent of the glacier tongue was recorded around 1810 at an elevation of 1,620 m asl (TIELIDZE et al. 2015: 76). In 1887 the glacier reached an altitude of 1,628 m asl (DECHY 1905: 314). As the altitude of HPP1 is about 1,645 m asl, it becomes evident that the extension of Chalaati glacier was below the current location of HPP1. In 1911 the glacier tongue reached an altitude of 1,650 m asl, just slightly above the location of HPP1, and the surface extent of the glacier was measured with 12.2 km² (PODOZERSKIY 1911). The moraine material consisted of gneiss granites, syenites with fine grain (feldspar and amphibolite) and pegmatides with quartz inclusions of different grain sizes (DECHY 2005).

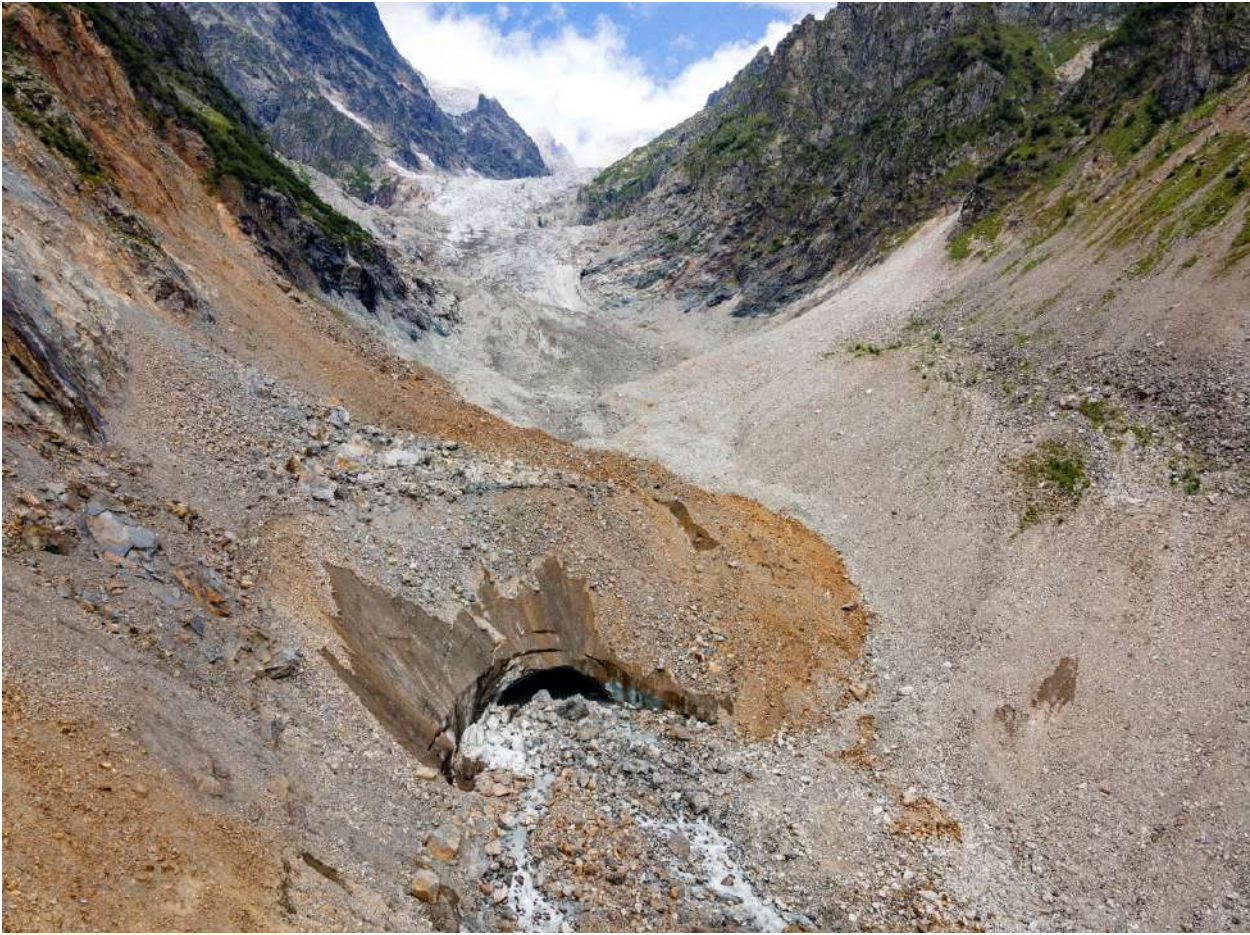
Fig. 9-2: Chalaati glacier terminus (© Sebastian Resinger)

Comparing information from the literature review with in-situ field observations, two different points in altitude for the current geographical position of the glacier terminus and mouth revealed. This may have occurred due to different interpretation of the ice body shown in Fig. 9-2. While in TIELIDZE 2020 the ice body is seen as dead ice, during the field survey it was interpreted as active glacier tongue. For an assessment of potential hazards originating at this location the question of whether the glacier mouth and the surrounding ice is dead ice or still an active part of the glacier can be neglected. Because the ice body is considerably debris covered, this distinction would need an in-depth analysis which was not possible giving the temporal constraints during the August 2020 field visit.

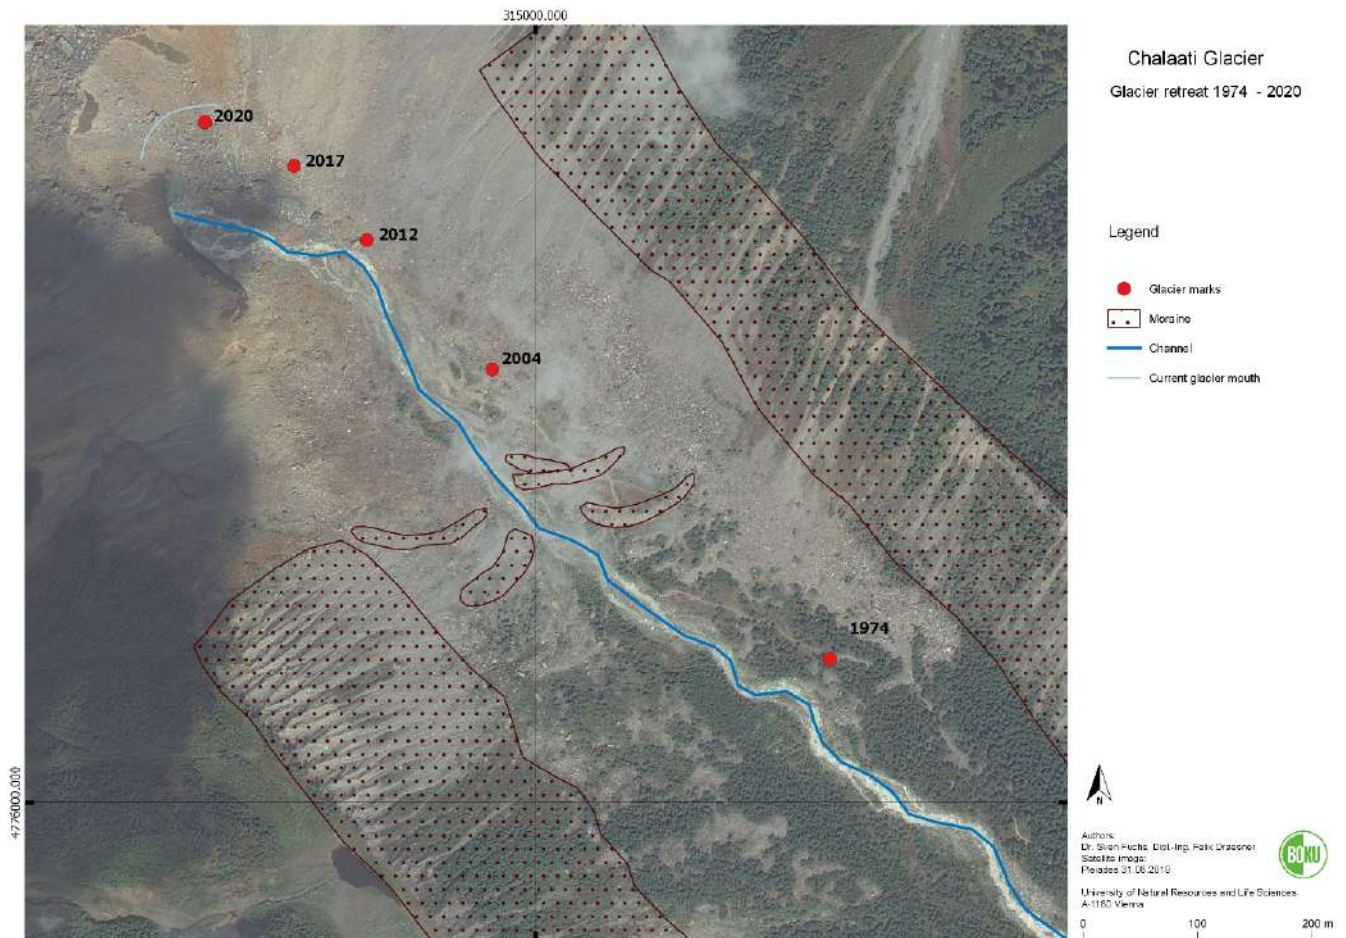
During the field survey on 14 August 2020, historic glacier levels and terminus marks were recorded using a GPS device. The marks were set by the Institute of Geography, Tbilisi State University and are located along the hiking trail between HPP1 and the glacier mouth. The recorded points were transferred into a GIS program to analyse the spatio-temporal glacier retreat rates. Besides, terminal and lateral moraines were mapped. Lateral moraines provide information on the former thickness of the glacier in the valley, and terminal moraine positions provide information on periods where neither retreat nor advance were dominant and therefore, the glacier tongue was in a stable position. The data is visualised in Fig. 9-3.

Fig. 9-3: Map of Chalaati glacier retreat 1974-2020

On the basis of the recorded glacier levels the retreat and decline can be measured. It has to be considered that the recorded waypoints only roughly correspond to the exact glacier levels of the corresponding year. For each year only one mark was found in the field, thus, the location of the lowest point of the glacier cannot be proven with absolute accuracy. Besides, no reference is made to the exact date of recording, and therefore a deviation of ± 20 m has to be assumed. As such, a rough estimation of the glacier retreat can be made.

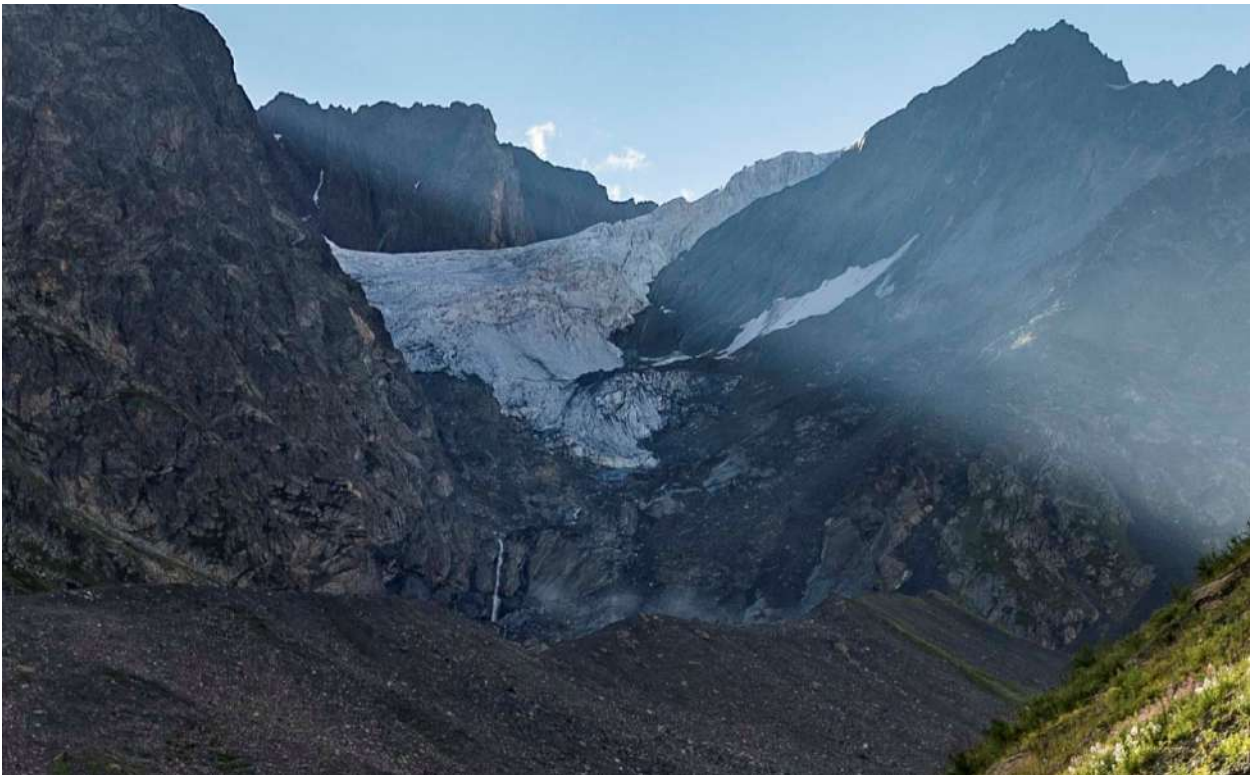
Only few data is available on the Murkvami glacier (Fig. 9-5). A GIS analysis showed that the current surface extent is around 1.5 km². Between the years 1960 and 1985, the retreat rate was around 21.4 meters per year, which totals 300 meters in 25 years (TIELIDZE 2017: 104). It has to be assumed that the glacier retreat is comparable to the neighboring glaciers Chalaati and Lekhziri. There is evidence that the stabilizing factor of the glacier will decrease and, as a consequence, an increasing amount of loose material becomes available for erosion and remobilization which poses a threat for the HPP constructions in particular if compound events occur. For details about such events please refer to Chapters 3 and 7.

Fig. 9-5: Murkvami glacier (© Sebastian Resinger)

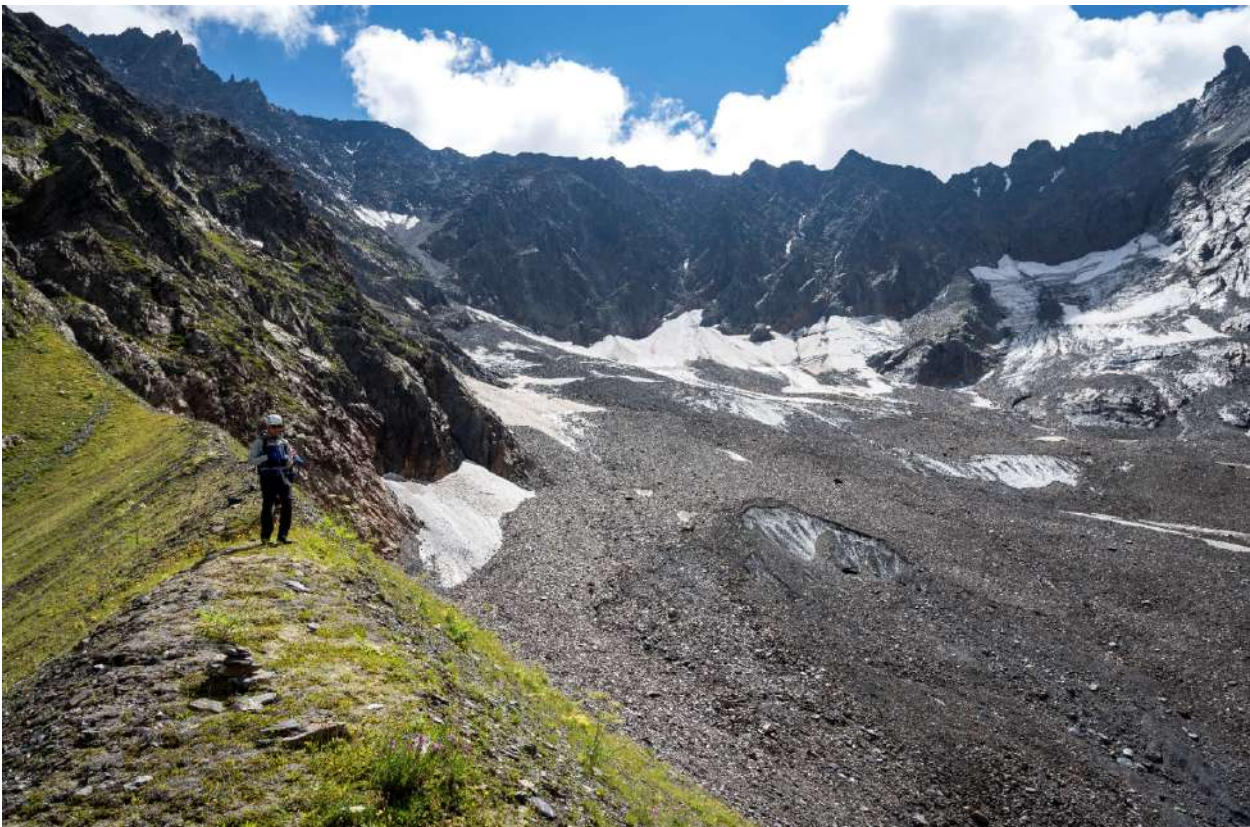
The debris-covered Banguriani glacier is located south of Murkvami glacier in the southern tributary valley of the Murkvami valley and has a current surface extent of about 0.3 km² (Fig. 9-6). Compared to the other glaciers in the Mestiachala valley, the catchment is rather small. It has to be assumed that a further retreat of this glacier will continue and increasing amounts of loose material will become available both, from the debris cover of the ice body as well as from the ground and side moraines. Because the inclination of the tributary valley is rather small, the Banguriani glacier was rated as being not very relevant as a source for future hazard events that may endanger HPP facilities.

Fig. 9-6: Debris-covered Banguriani glacier (© Sebastian Resinger)

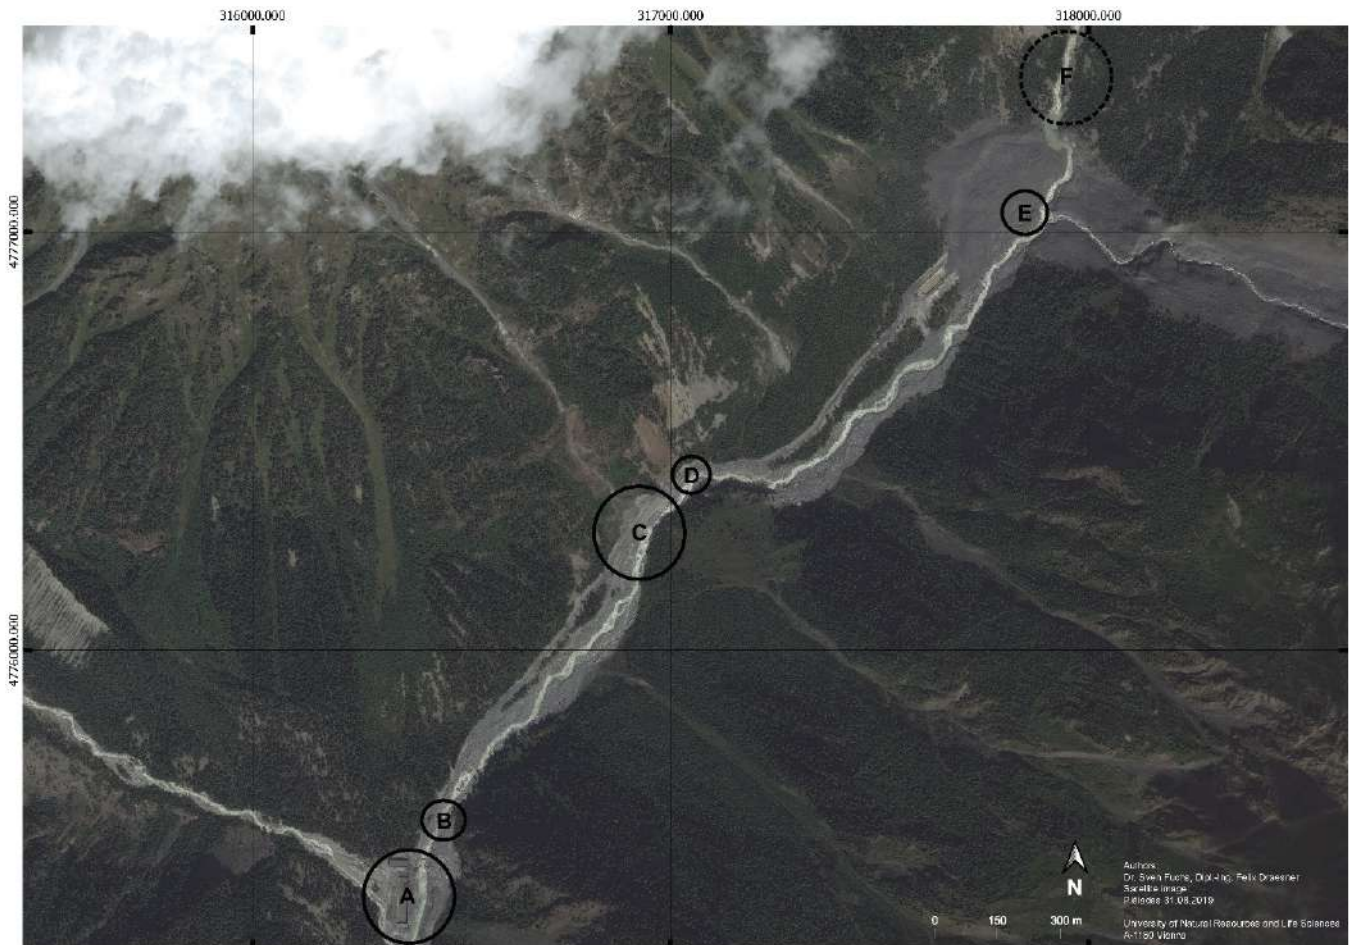
Fig. 10-1: Map of the locations of HPP 1 constructions: A = HPP, B = suspension bridge, C = gallery, D = exposed penstock, E = former intake1, F = estimated position of alternative intake 1.

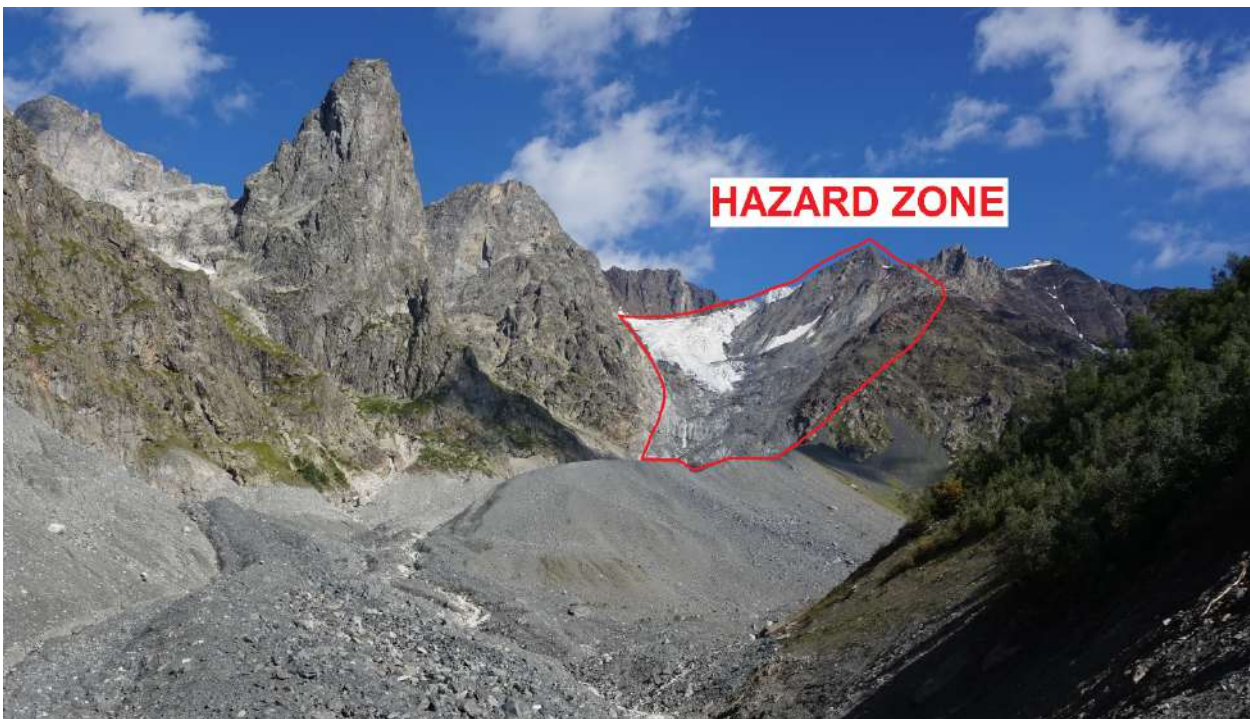
Fig. 11-1: Image showing an overview of the overall hazard zone for observation. See also Fig. 8-15 for entire release zone overview.

The aim of the proposed sentry monitoring and alarm system is to permanently observe the defined hazard zone shown in Fig. 11-1 and Fig. 11-2 in the tributary valley by a security guard. The total detachments of July 2019 and subsequently are shown in Attachment 10 according to

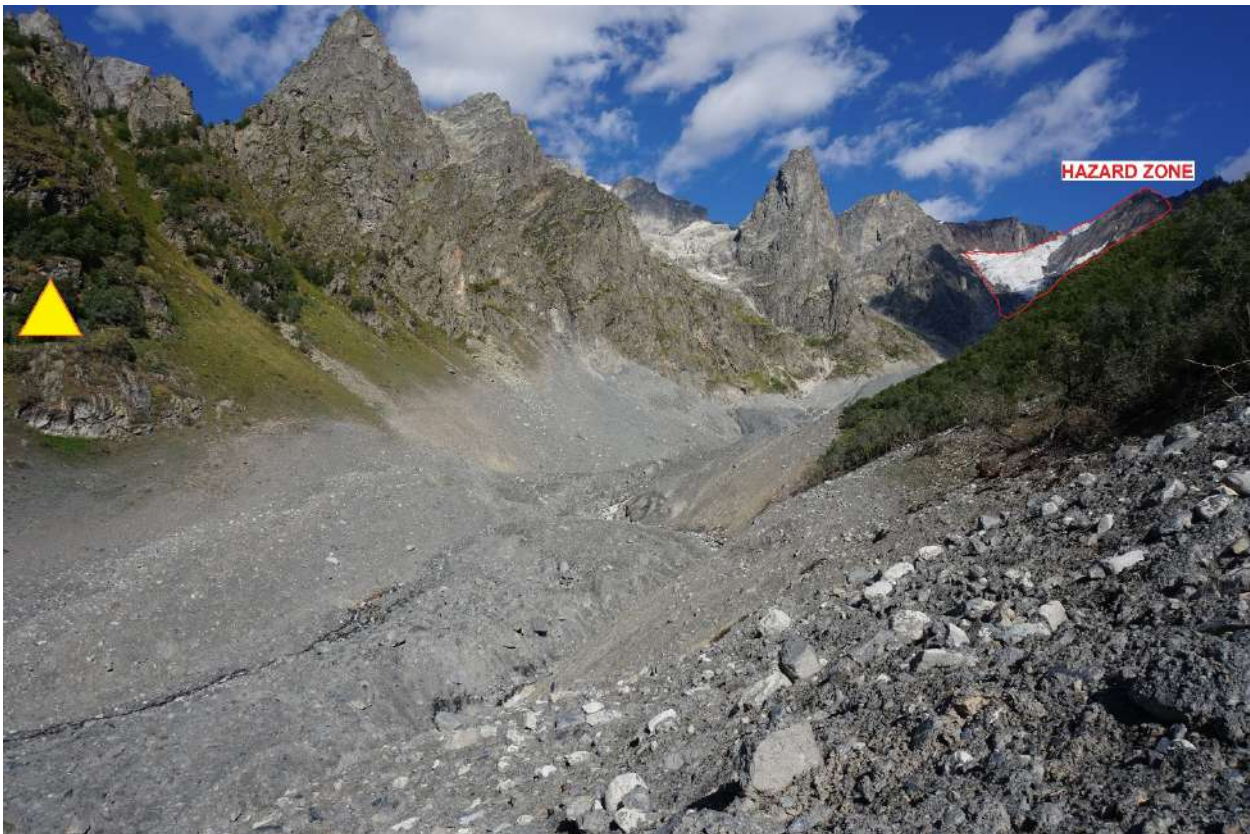
Fig. 11-3: Image showing proposed location of sentry spot (yellow triangle).

The basic idea of the concept is to install a permanent sentry in the lower section of the tributary valley at the location shown in Fig. 11-3. From this position the hazard zone is visible and in case of an event the sentry point location can be considered as a safe place based on the visible evidences from the 2019 event. A trained and instructed person should be selected to serve the sentry spot during the daily operation time of the construction site in the Mestiachala valley or as long as local or international staff is operating somewhere in between the powerhouse 1 and the hazard zone.

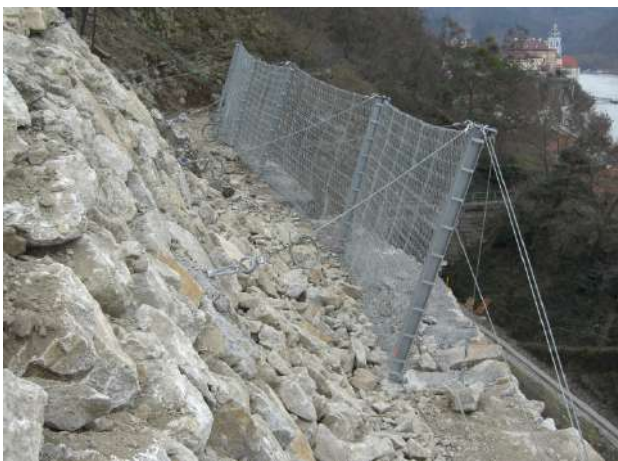
Fig. 12-1: Technical rockfall protection fence (2,000 kJ) on a dam embankment

During the construction phase of the new intake 1 structure employees are endangered by rockfall from M-D6. Therefore, it is not only essential to protect the intake structure itself but also to protect employees working in exposed areas. Implementing a rockfall barrier at M-D6 has to be completed before constructing the new intake 1 structure. Examples for technical rockfall protection fences are shown in Fig. 12-1 and Fig. 12-2. In case of a rockfall event hitting either the new intake 1 structure or the penstock the operation of the power plant is no longer ensured. Hence, a failure of the protection structure is associated with considerable economic loss. According to the ONR 24810 these “high economic consequences” require the classification as consequence class 3 (severe, CC3). For the proof of concept with CC3, a safety factor of 1.15 for both load and resistance has to be applied. Following this concept we propose a technical rockfall protection fence with at least 2,000 kJ resistance for both hazard areas (for example “TSV-2000 ZD H4”, see Fig. 12-3 and Fig. 12-4). The system should use steel components and steel wire ropes made from high-quality materials, following a stringent quality assurance program. The structure needs to be tested and certified as per ETAG 27 according to the European Technical Assessment ETA-14/0357. Some characteristic values of an appropriate system are summarized in Tab. 12-1. The exact location, the operating height as well as anchoring has to be determined in a further step. At location M-D6 an additional load from avalanche snow has to be considered. During winter the barrier will be backfilled with snow which exerts pressure to the posts, causes an activation of the break elements, and pre-elongates the deformable net, if not correctly dimensioned. Hence, it is crucial for durability reasons to take this load into account. Some characteristic values of an appropriate system regarding snow load are summarized in Tab. 12-2.

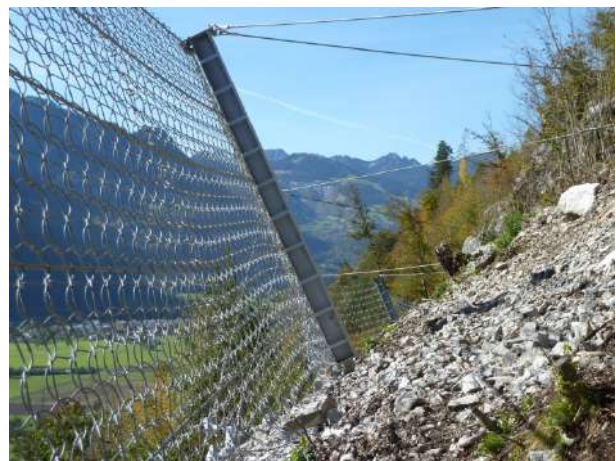
Fig. 12-2: Technical rockfall protection fence (2,000 kJ) on a natural slope

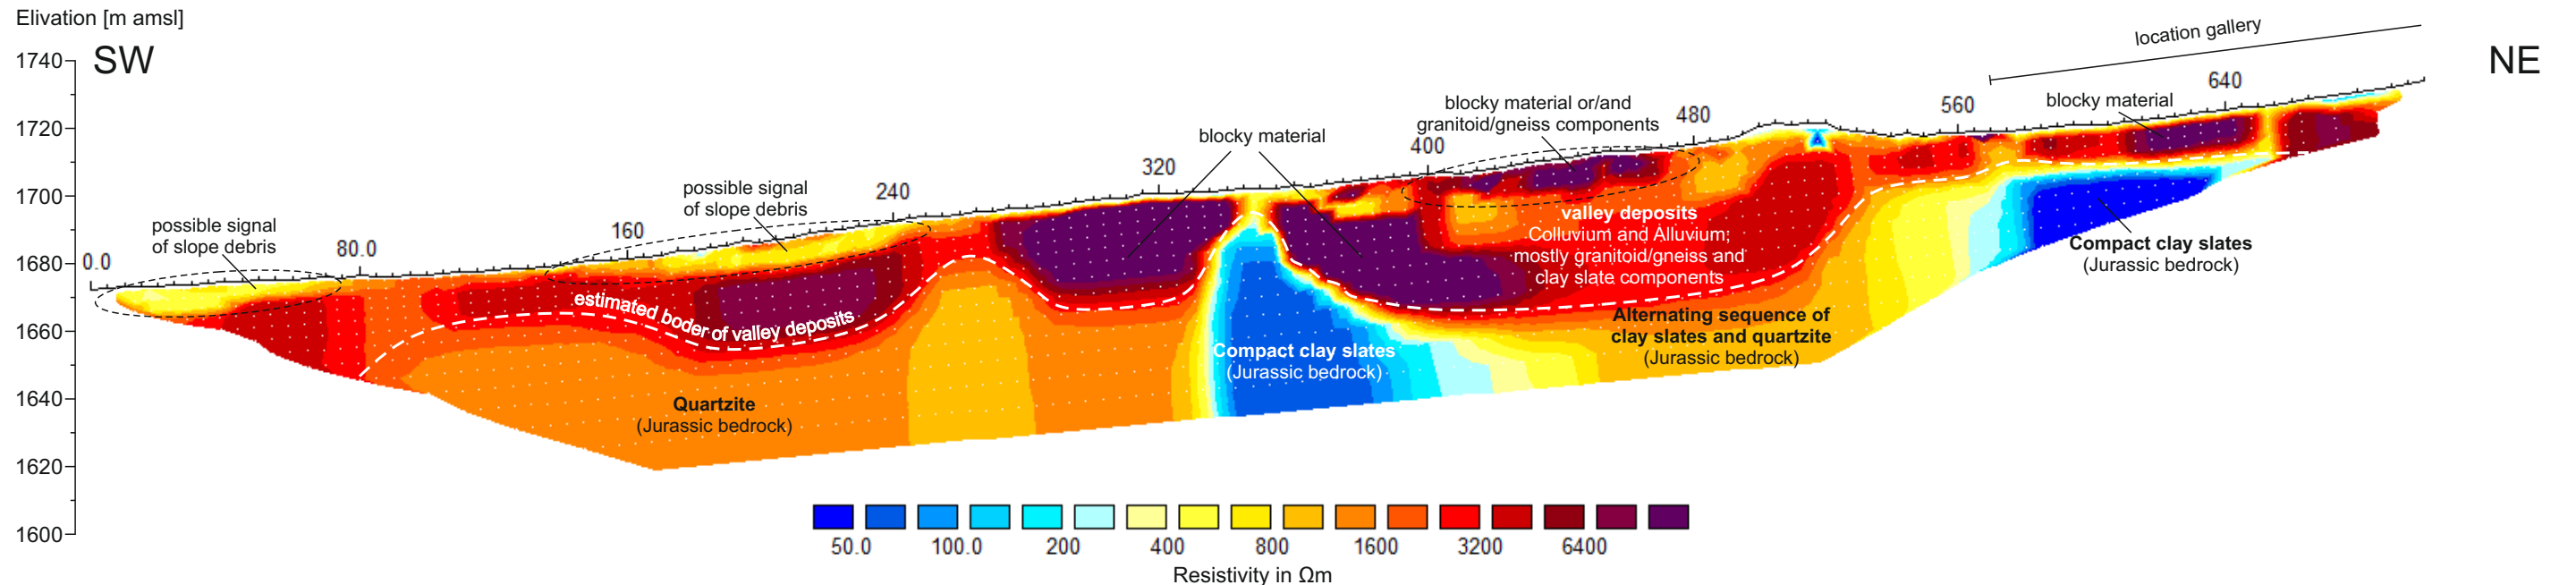
Geoelectrical transect - „Mestiachala, gallery”
Scale 1 : 2,000

Model resistivity with topography
Iteration 8 Abs. error = 2.9

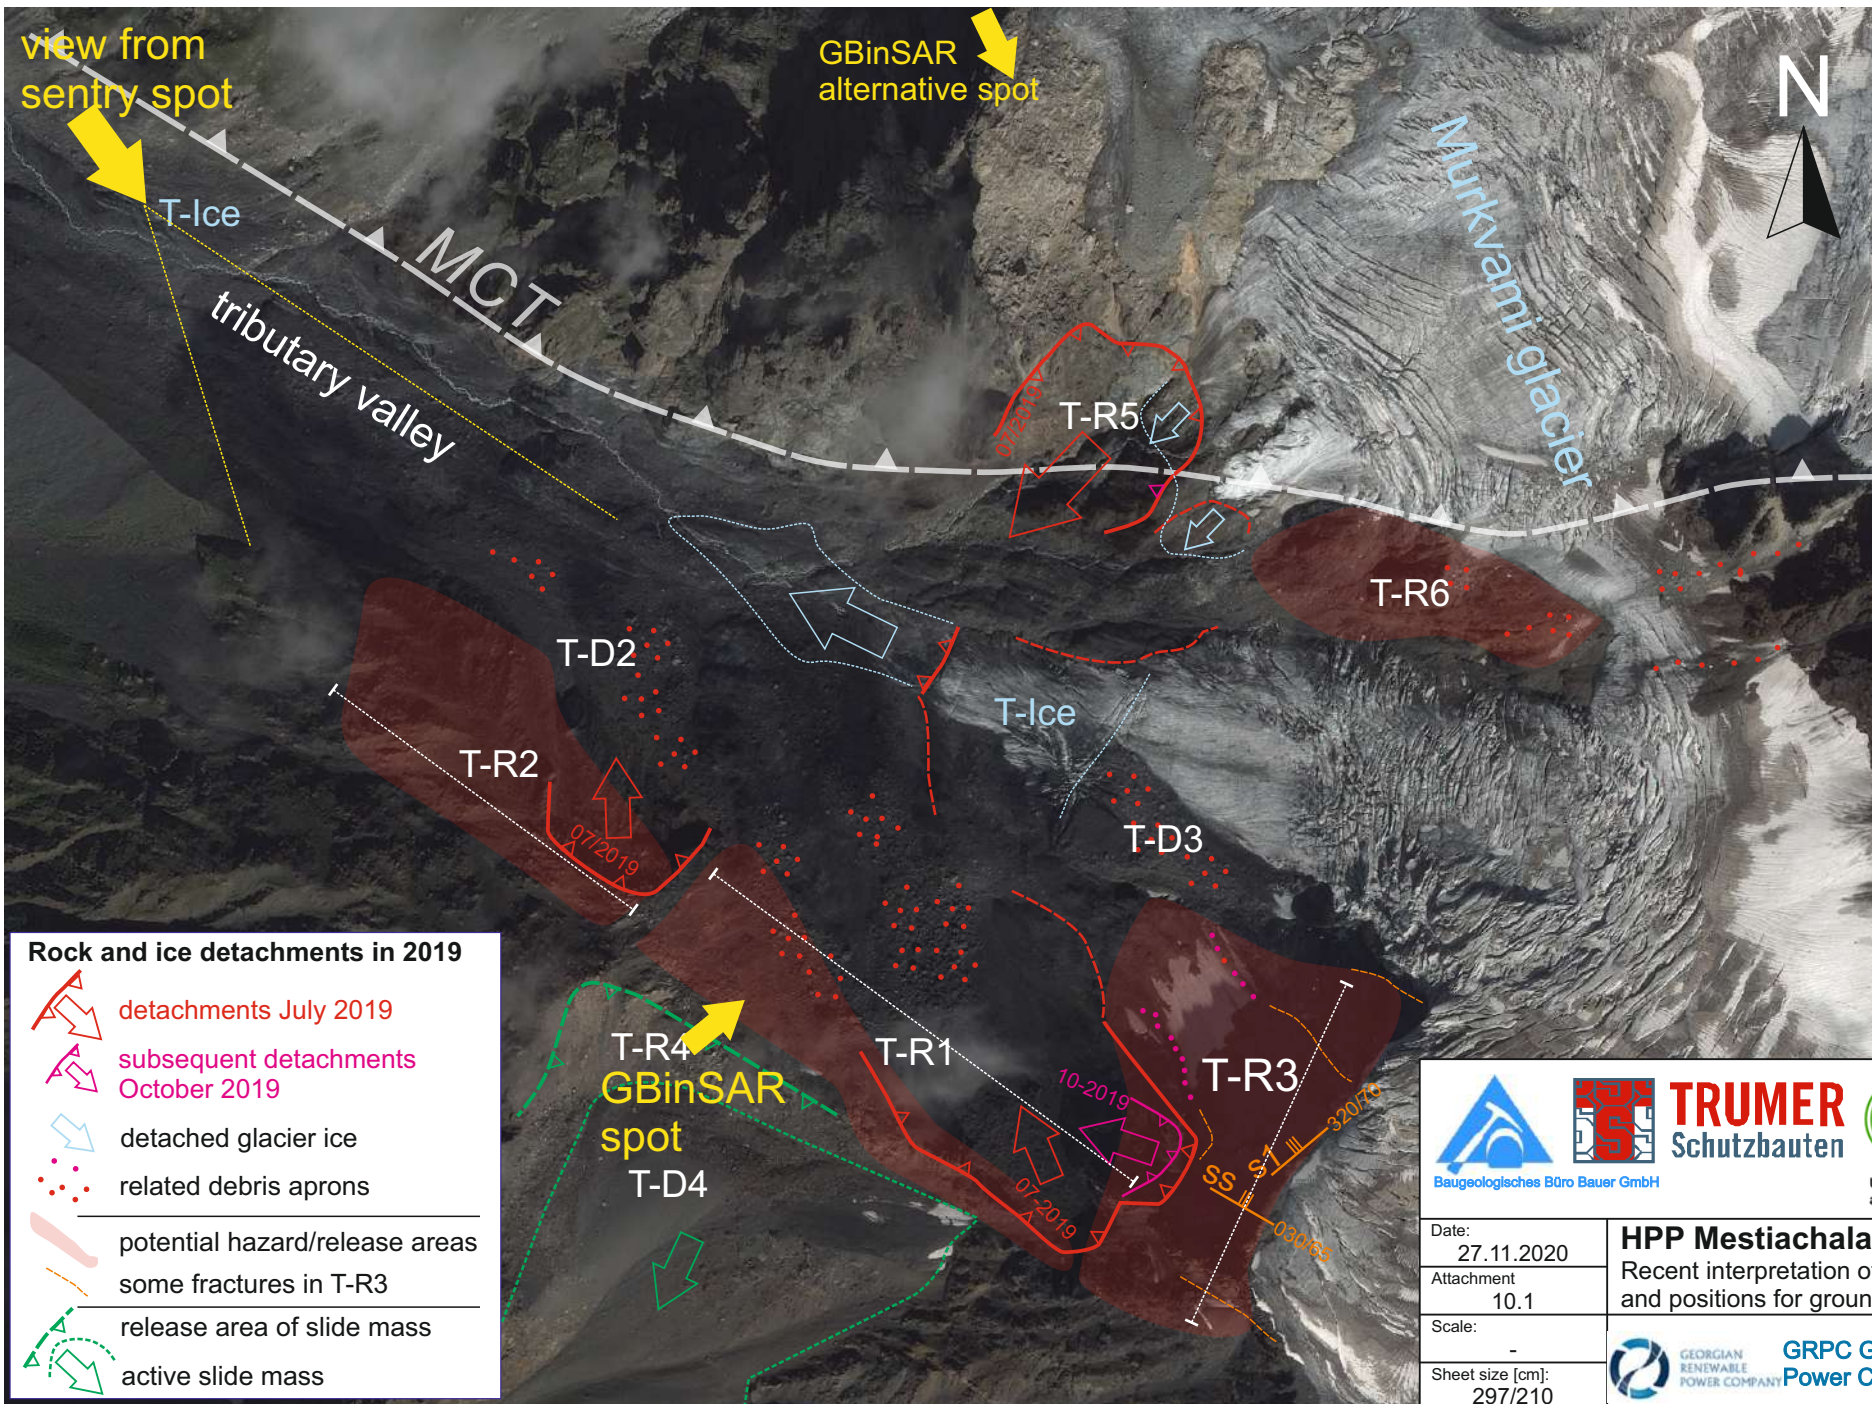
Attachment 10 Monitoring of the July 2019 detachment
area

Rock and ice detachments in 2019

potential hazard/release areas
-

some fractures in T-R3
-
